**Flood Control Project Maintenance
Levee Inspections**
LMA District Cover Sheet
Spring 2009 Levee Inspection Results

Reclamation District No. 0003

**Flood Control Project Maintenance
Levee Inspections
Unit Cover Sheet
Spring 2009 Levee Inspection Results
Reclamation District No. 0003**

Waterway		Bank	Unit Miles
Unit No. 01 Left Bank Steamboat Slough		Left	11.00

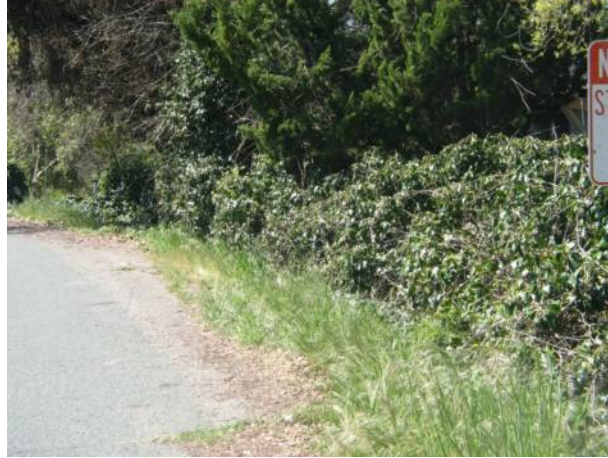
Levee Mile Report Line	7
Start Levee Mile	0.22
End Levee Mile	0.33
Location	Water Side
Category	Earthen Levee
Item	Encroachments

Dense landscaping on waterside from LM 0.22 to 0.28

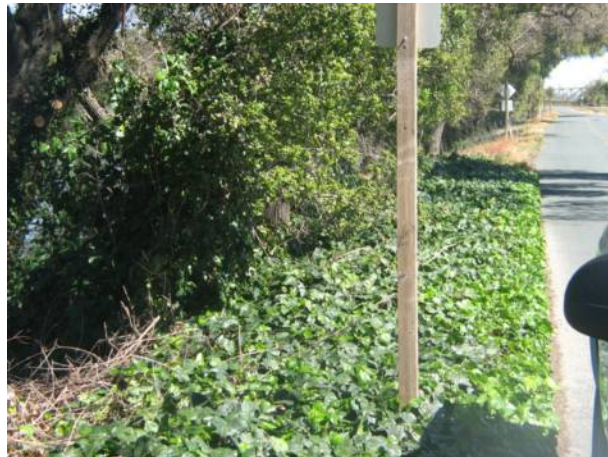
Levee Mile Report Line	7
Start Levee Mile	0.22
End Levee Mile	0.33
Location	Water Side
Category	Earthen Levee
Item	Encroachments

Looking upstream at dense landscaping on waterside slope from LM 0.22 to 0.28

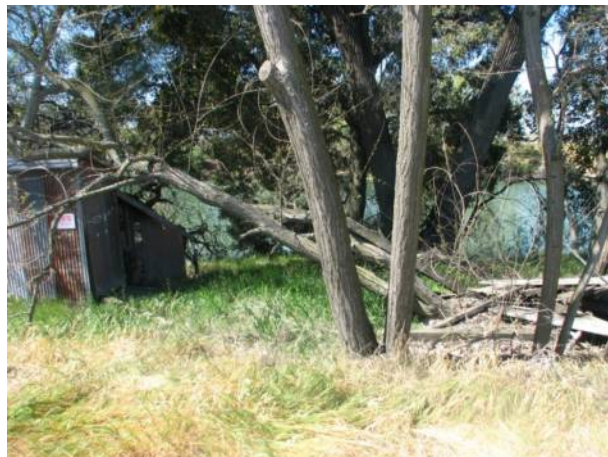
Levee Mile Report Line	10
Start Levee Mile	0.58
End Levee Mile	0.58
Location	Water Side
Category	Earthen Levee
Item	Encroachments

Down tree limbs on waterward slop at LM 0.58

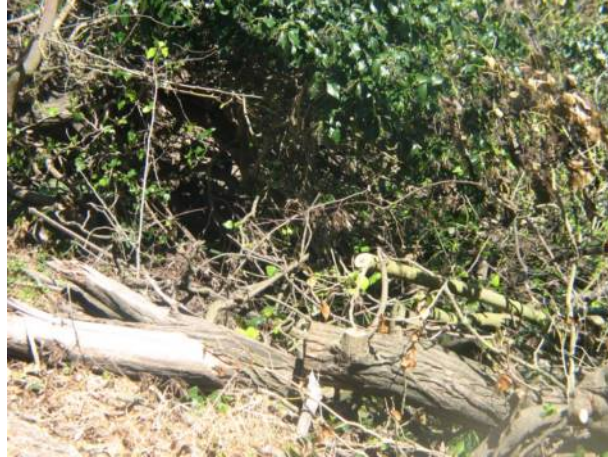
Levee Mile Report Line	15
Start Levee Mile	1.08
End Levee Mile	1.09
Location	Land Side
Category	Earthen Levee
Item	Trim / Thin Trees
Down tree limbs on landside slope from LM 1.08 to 1.09

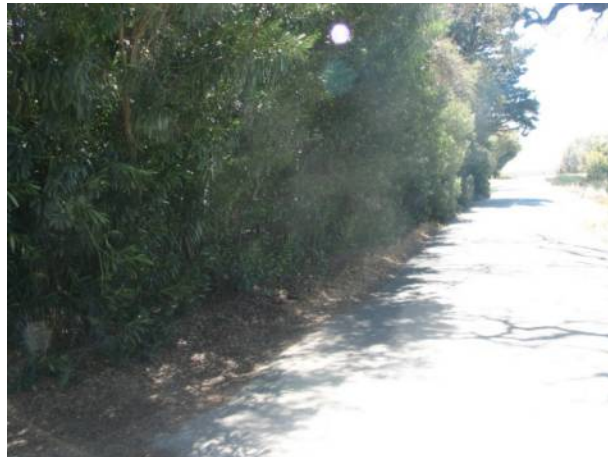
Levee Mile Report Line	16
Start Levee Mile	1.21
End Levee Mile	1.27
Location	Land Side
Category	Earthen Levee
Item	Encroachments
Landscaping on landside slope block view of levee from LM 1.21 to 1.27

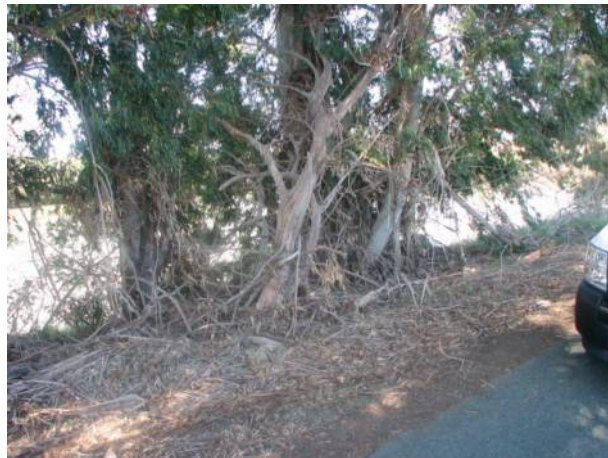
Levee Mile Report Line	24
Start Levee Mile	2.69
End Levee Mile	2.69
Location	Water Side
Category	Earthen Levee
Item	Encroachments
Down tree limbs on waterside slope.

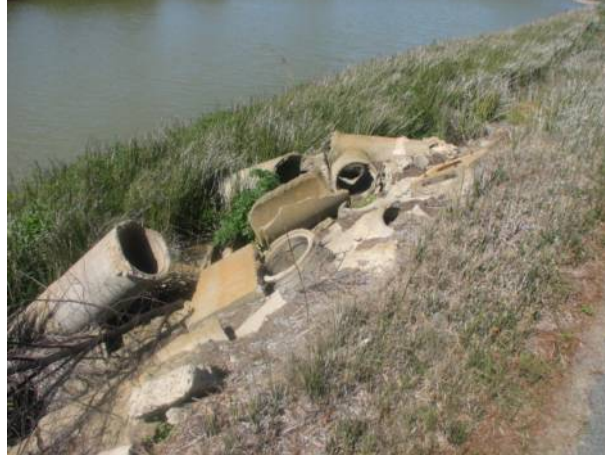
Levee Mile Report Line	27
Start Levee Mile	3.15
End Levee Mile	3.15
Location	Water Side
Category	Earthen Levee
Item	Encroachments
Concrete rubble on waterside slope.

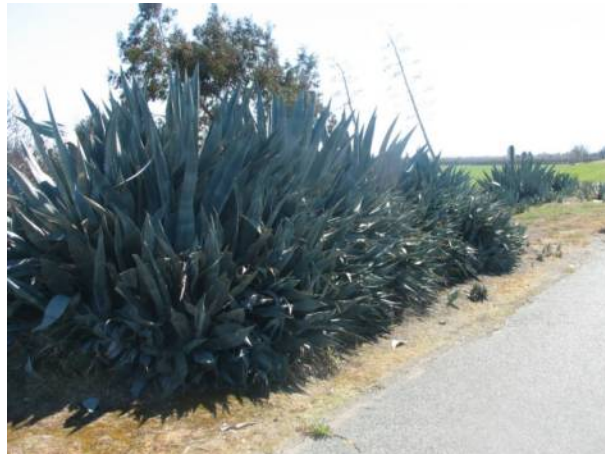
Levee Mile Report Line	35
Start Levee Mile	7.08
End Levee Mile	7.10
Location	Land Side
Category	Earthen Levee
Item	Encroachments
Large Cactus plant on landside shoulder block view of levee slope from LM 7.08 to 7.10

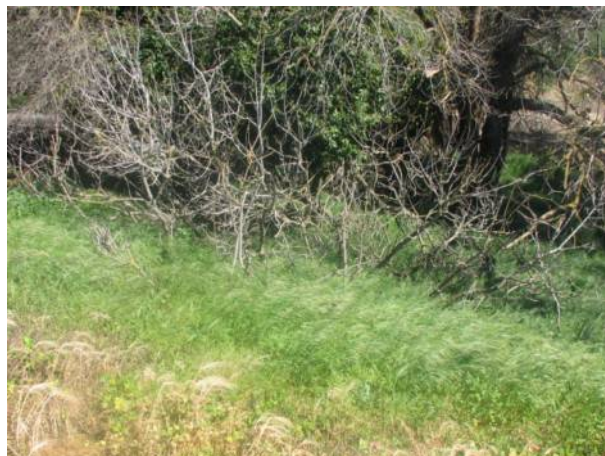
Levee Mile Report Line	36
Start Levee Mile	7.81
End Levee Mile	7.83
Location	Water Side
Category	Earthen Levee
Item	Encroachments
Front view of dense trees at landside toe.

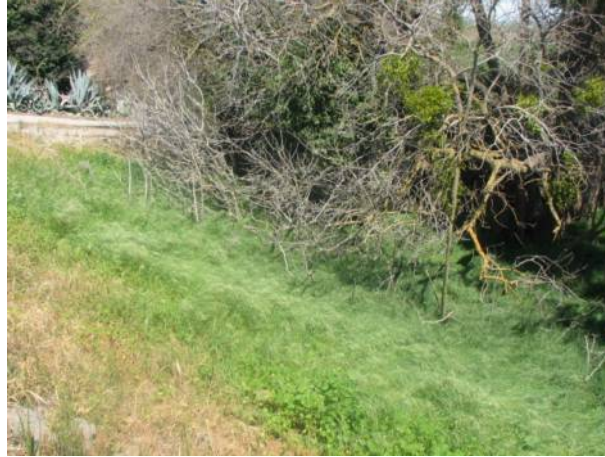
Levee Mile Report Line	36
Start Levee Mile	7.81
End Levee Mile	7.83
Location	Water Side
Category	Earthen Levee
Item	Encroachments

Side view of dense trees at landside toe.

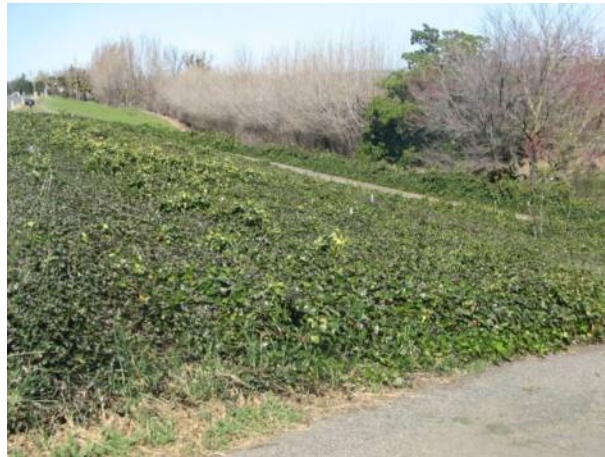
Levee Mile Report Line	37
Start Levee Mile	7.95
End Levee Mile	8.00
Location	Land Side
Category	Earthen Levee
Item	Encroachments

Landscaping (Ivy) on landside slope blocking view of levee from LM 7.95 to 8.00

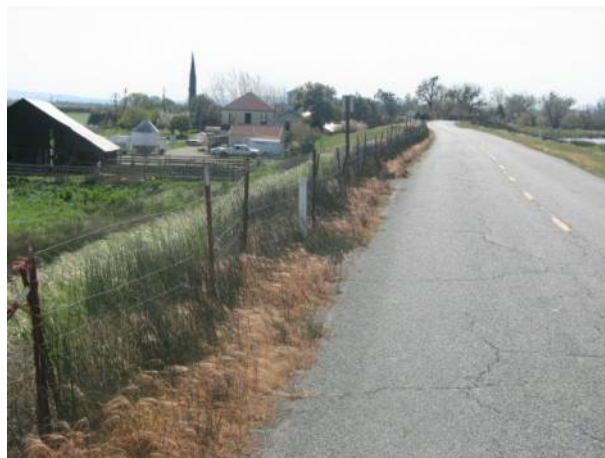
Levee Mile Report Line	39
Start Levee Mile	8.94
End Levee Mile	8.94
Location	Land Side
Category	Earthen Levee
Item	Encroachments

Fence is located at landside shoulder

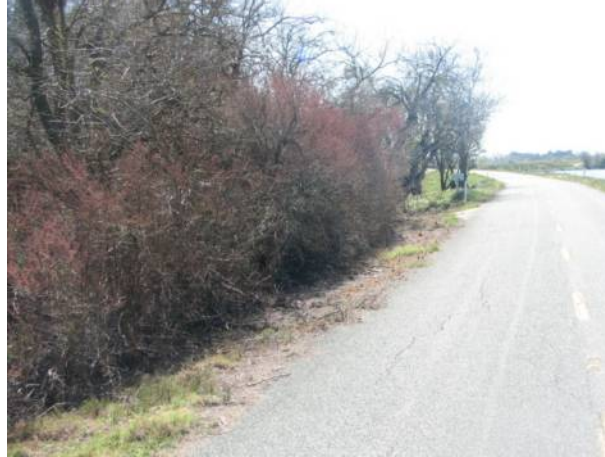
Levee Mile Report Line	41
Start Levee Mile	10.20
End Levee Mile	10.22
Location	Land Side
Category	Earthen Levee
Item	Trim / Thin Trees
Trees to be trimmed on landside shoulder from LM 10.20 to 10.22

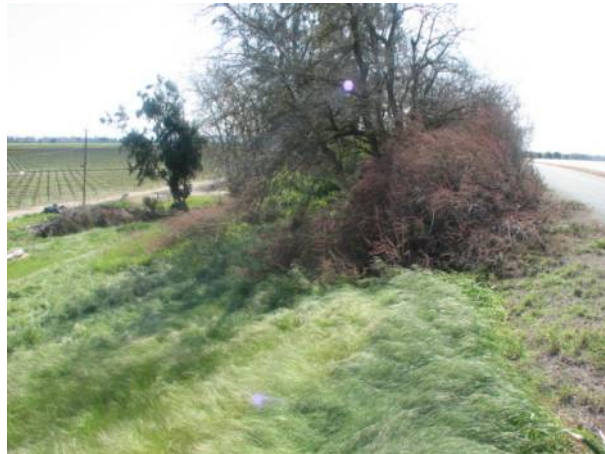
Levee Mile Report Line	41
Start Levee Mile	10.20
End Levee Mile	10.22
Location	Land Side
Category	Earthen Levee
Item	Trim / Thin Trees
Side view of trees on landside shoulder.

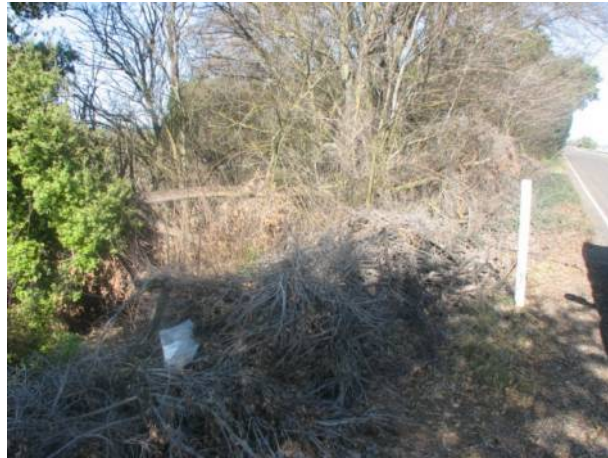
Levee Mile Report Line	3
Start Levee Mile	1.52
End Levee Mile	1.52
Location	Land Side
Category	Earthen Levee
Item	Trim / Thin Trees

Side view of trees to be trimmed on landside shoulder.

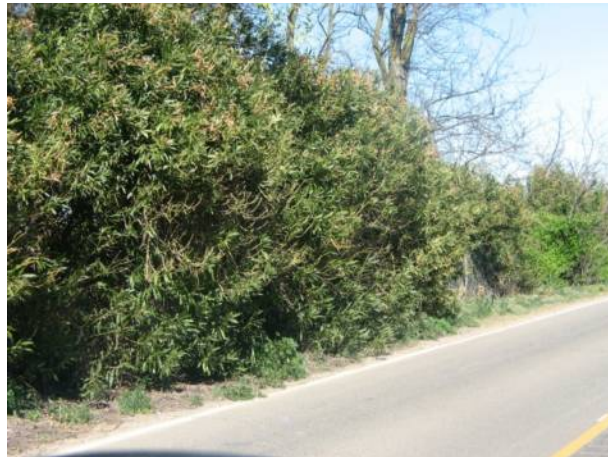
Levee Mile Report Line	18
Start Levee Mile	5.94
End Levee Mile	6.00
Location	Land Side
Category	Earthen Levee
Item	Encroachments

Oleander on landside shoulder blocking view of levee slope from LM 5.94 to 6.00

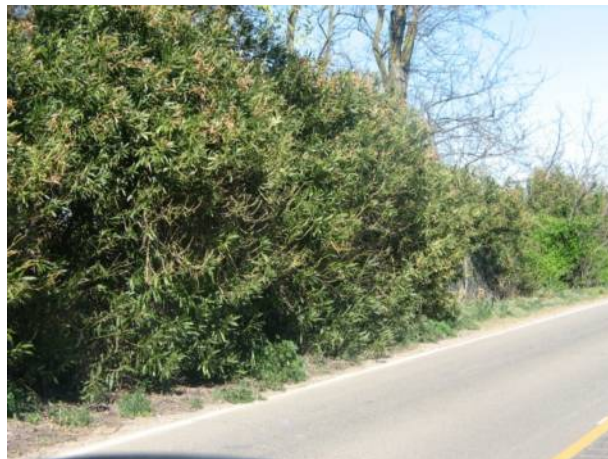
Levee Mile Report Line	18
Start Levee Mile	5.94
End Levee Mile	6.00
Location	Land Side
Category	Earthen Levee
Item	Encroachments

Oleander on landside shoulder blocking view of levee slope from LM 5.94 to 6.00

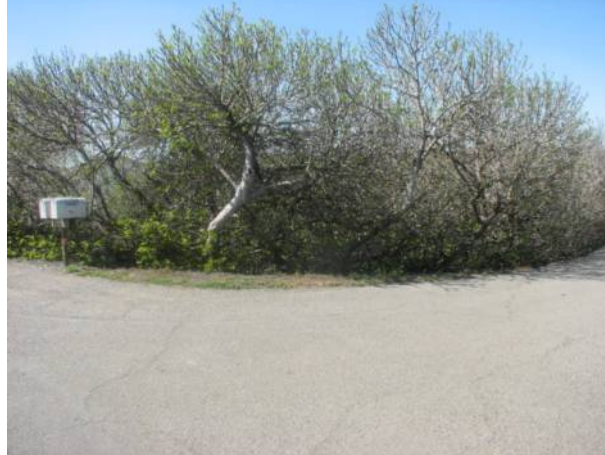
Levee Mile Report Line	19
Start Levee Mile	6.00
End Levee Mile	6.00
Location	Land Side
Category	Earthen Levee
Item	Encroachments

Front view of dense trees at landside shoulder.

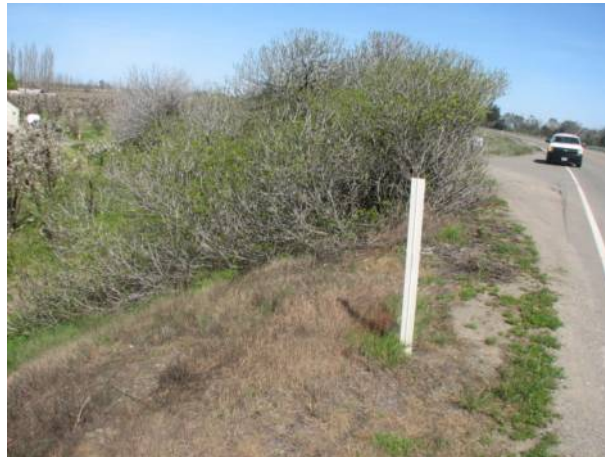
Levee Mile Report Line	19
Start Levee Mile	6.00
End Levee Mile	6.00
Location	Land Side
Category	Earthen Levee
Item	Encroachments

Side view of dense trees at landside shoulder and slope.

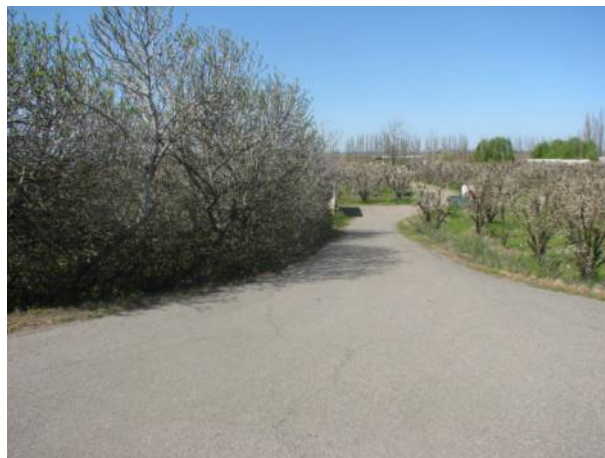
Levee Mile Report Line	19
Start Levee Mile	6.00
End Levee Mile	6.00
Location	Land Side
Category	Earthen Levee
Item	Encroachments

Side view of dense trees along landowner ramp.

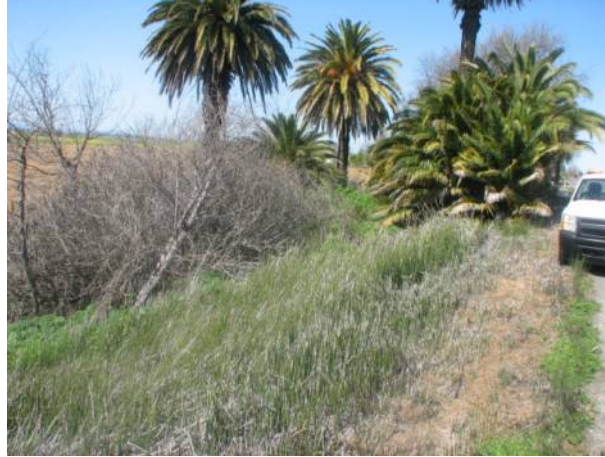
Levee Mile Report Line	21
Start Levee Mile	7.02
End Levee Mile	7.04
Location	Land Side
Category	Earthen Levee
Item	Trim / Thin Trees

Dense trees at landside toe and shoulder

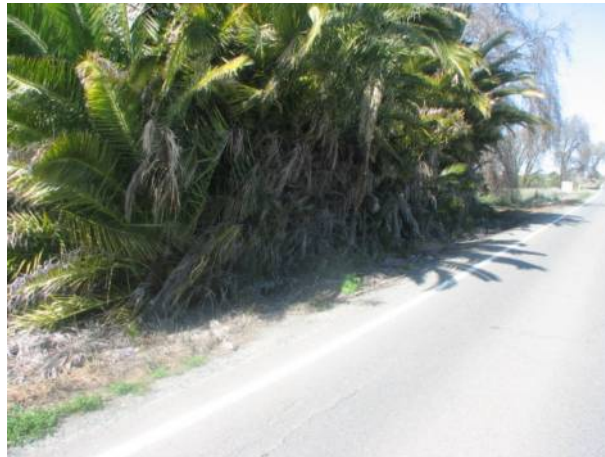
Levee Mile Report Line	21
Start Levee Mile	7.02
End Levee Mile	7.04
Location	Land Side
Category	Earthen Levee
Item	Trim / Thin Trees

Front view of palm trees on landside shouldr

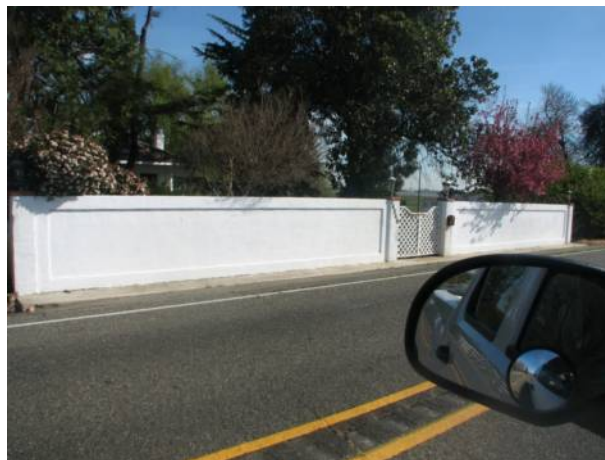
Levee Mile Report Line	30
Start Levee Mile	10.13
End Levee Mile	10.13
Location	Land Side
Category	Earthen Levee
Item	Encroachments

Block/Concrete fence on landside shoulder at LM 10.13

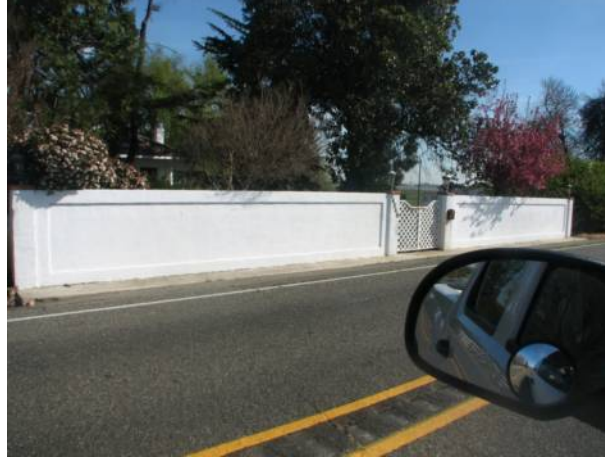
Levee Mile Report Line	30
Start Levee Mile	10.13
End Levee Mile	10.13
Location	Land Side
Category	Earthen Levee
Item	Encroachments
Block/Concrete fence on landside shoulder at LM 10.13

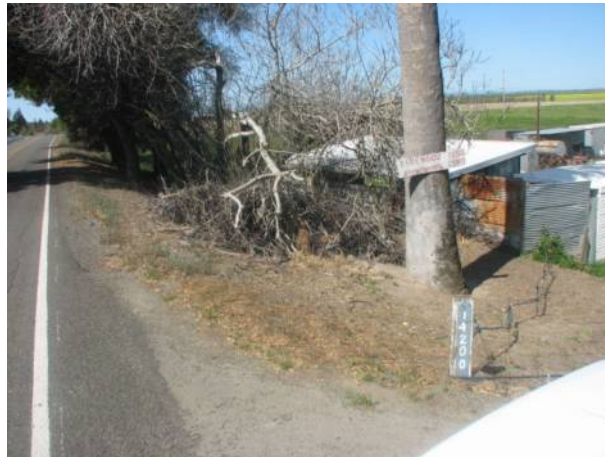
Levee Mile Report Line	38
Start Levee Mile	11.42
End Levee Mile	11.42
Location	Land Side
Category	Earthen Levee
Item	Encroachments
Down tree limbs on landside slope.

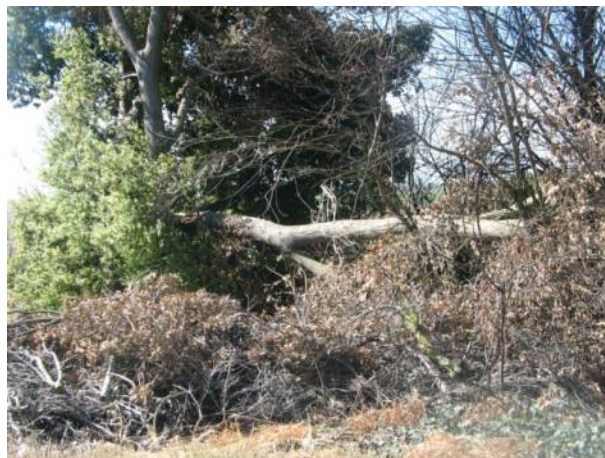
Levee Mile Report Line	71
Start Levee Mile	15.83
End Levee Mile	15.83
Location	Land Side
Category	Earthen Levee
Item	Encroachments
Down tree limbs on landside slope at LM 15.83

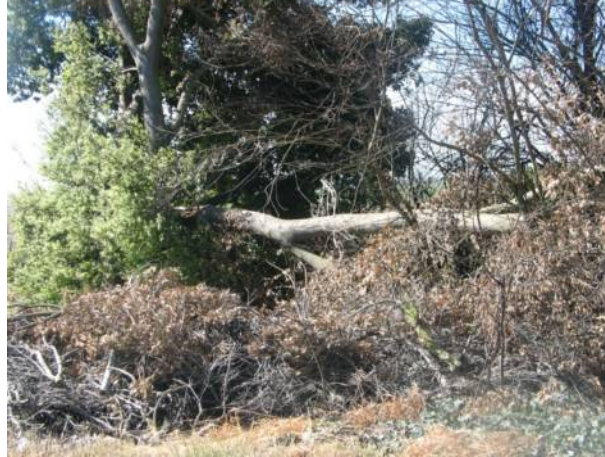
Levee Mile Report Line	71
Start Levee Mile	15.83
End Levee Mile	15.83
Location	Land Side
Category	Earthen Levee
Item	Encroachments

Down tree limbs on landside slope at LM 15.83
